The Effect of Hard Particle Wear on Diesel Injectors

Summary of Industry Cooperative Diesel Injector Hard Particle Wear Testing Conducted at Southwest Research Institute (SwRI)

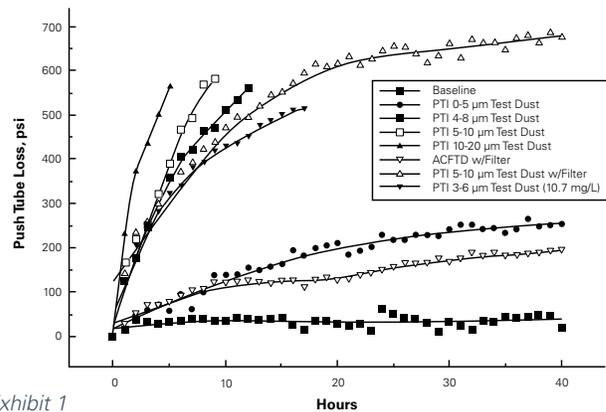
Exhibit 1

The **Baseline** (black squares across the bottom line ■), run with completely clean fuel, shows no increase in push tube load loss over the run time of the test.

The **PTI 0-5 µm Test Dust** (black circles ●) caused at most a modest increase in push tube load loss.

The **PTI 4-8 µm Test Dust** (black squares ■) caused a dramatic increase in push tube load loss almost immediately.

The **PTI 5-10 μm Test Dust** (white squares \square) also caused a dramatic increase in push tube load loss.

The **PTI 10-20 μm Test Dust** (black triangles \blacktriangle) caused the most dramatic increase in push tube load loss.

The **ACFTD** (AC fine test dust) with Filter (upside down white triangle ∇), is an example of contaminated fuel with a filter of sufficient efficiency to protect the injector from damage over the course of the test.

The **PTI 5-10 μm Test Dust w/ Filter** (white triangle Δ), is an example of a cut of dust that did damage without filtration and again did damage with a filter of insufficient efficiency in place that failed to protect the unit injectors.

The **PTI 3-6 μm Test Dust** (10.7mg/l) is a sample with a contamination levels on the high end of average for real world fuel and is shown to do rapid, severe damage to the injectors.

Based on this data, it was determined that particulate 6-7 μm and larger was likely to cause significant “push tube load loss”, due to abrasive wear. This correlates to a decrease in fuel injection pressure.

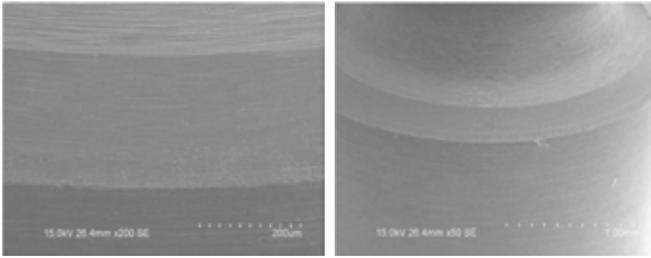
SEM: 0.8 -2.5 μm highest leakage upper valve seat at 200X magnification on left and 50X on the right.

The valve seat images above show only a few extremely mild signs of wear from particulate after testing on the 0.8-2.5 μm dust loaded fuel. There are some very minor particle indentations along the upper valve seat, and the lower valve housing shows only break in wear and original machining marks.

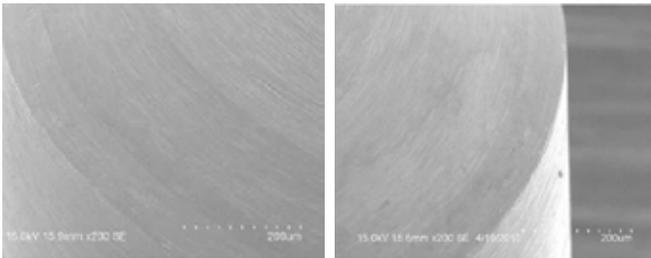
SEM: 0.8 -2.5 μm highest leakage lower valve seat at 200X magnification.

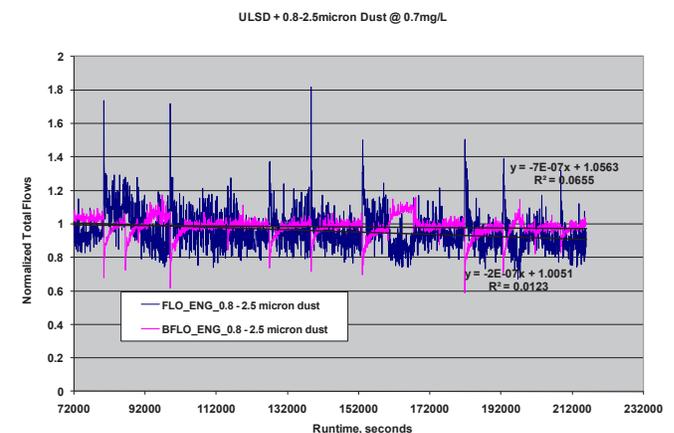
The system with 0.8-2.5 μm dust-contaminated fuel was run for 41 hours, disassembled and inspected for damage. Data from the run shown in Exhibit 4 indicates that there was little to no change in flow of fuel to the injector or bypass flow back to the tank.

This indicates that the majority of particles in the 0.8-2.5 μm contaminated fuel are not likely to be a concern for the HPCR fuel system components. This correlates nicely with the SEM images of the highest leakage valve seats.

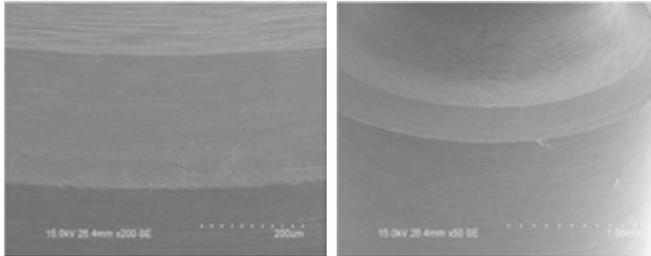
SEM: 0.8 -2.5 μm highest leakage upper valve seat at 200X magnification on the left and 50X on the right.

The above valve seat images above show only a few extremely mild signs of wear from particulate after testing on the 0.8-2.5 μm dust loaded fuel. There are some very minor particle indentations along the upper valve seat, the lower valve housing shows only break in wear and original machining marks.

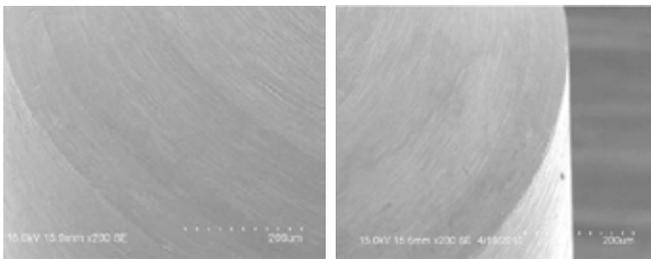
SEM: 0.8 -2.5 μm highest leakage lower valve seat at 200X magnification.

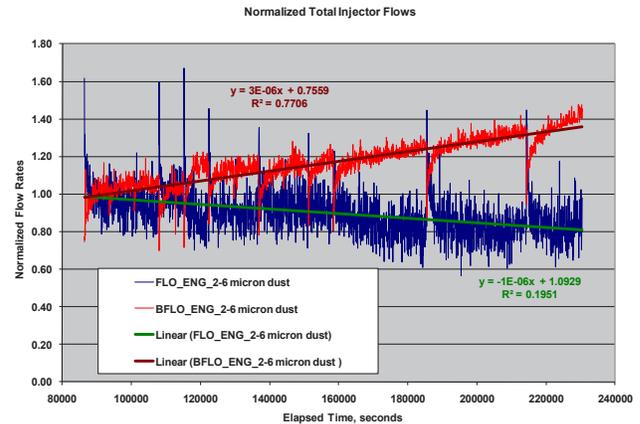
The system with 2-6 μm dust contaminated fuel was run for 41 hours, disassembled and inspected for damage. Data from the run shown in Exhibit 5 indicates that there was an immediate change in flow of fuel to the injector or bypass flow back to the tank. This change continued over the entire test run. This indicates that damage is being done to the HPCR system.

As seen in Exhibit 5, the constant increase in back to tank flow (BFLO_ENG_2-6 micron dust) in this case started immediately and continued for roughly 41 hours. This behavior tends to correlate with injector seat damage.

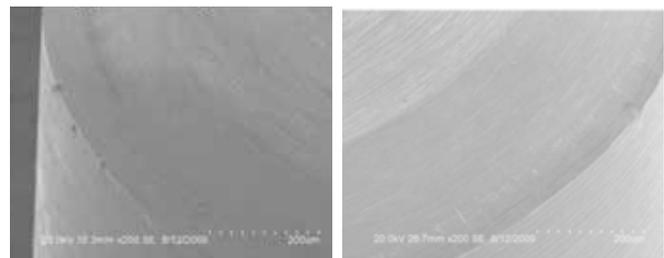
In the upper seat images, particle indentations can be seen having formed as the surfaces come together with particles present between them causing initial damage. There is the beginning indications of erosion, visible as a thin, straight line across the sealing surface. In the lower seat image on the right, the development of a significant

SEM: 2 -6 μm highest leakage Lower/ Upper valve seat both at 200X magnification.

erosion channel can be seen. This is caused by the flow of high pressure liquid containing particulate beginning to pass from one side of the seal to the other, even when closed; thus eroding the channel as flow continues. These channels develop when the small, round impact indentations formed when particles are initially trapped between the mating surfaces, increase in number to the point that they connect together and flow begins passing through the damage channels.

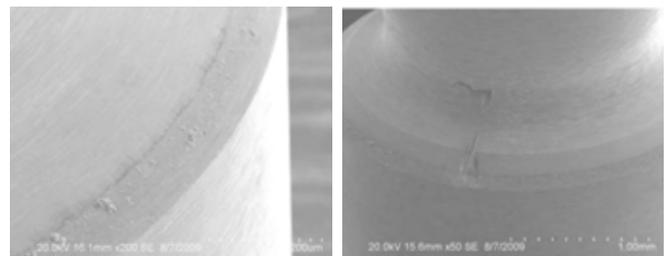
SEM: 2 -6 μm lowest leakage lower valve seat at 200X on the left and 50X magnification on the right.

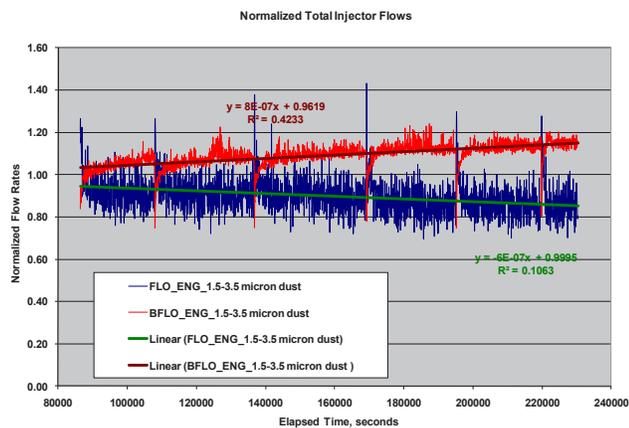
Exhibit 6

As shown in Exhibit 6, the constant increase in back to tank flow (BFLO_ENG_1.5-3.5 micron dust) started immediately and continued as the system continues operation for roughly 41 hours.

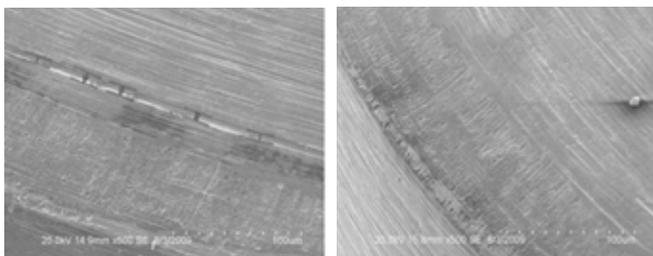
In both the lower and upper seat images a high number of indentations can be seen that are caused by hard particles being present as the seal faces close. On the upper seat images the beginnings of erosion channels are visible. The lower seal faces also show small indentations beginning to connect due to erosion.

SEM: 1.5 -3.5 µm lowest leakage lower valve seat both at 500X magnification.

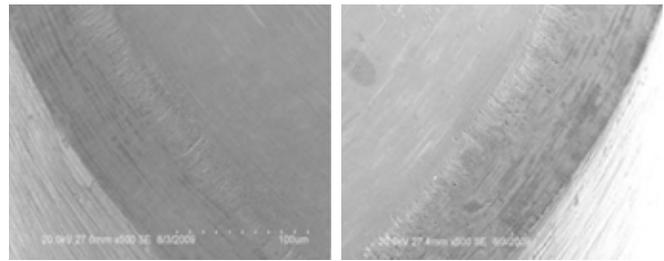
SEM: 1.5 -3.5 µm highest leakage upper valve seat at 500X magnification.

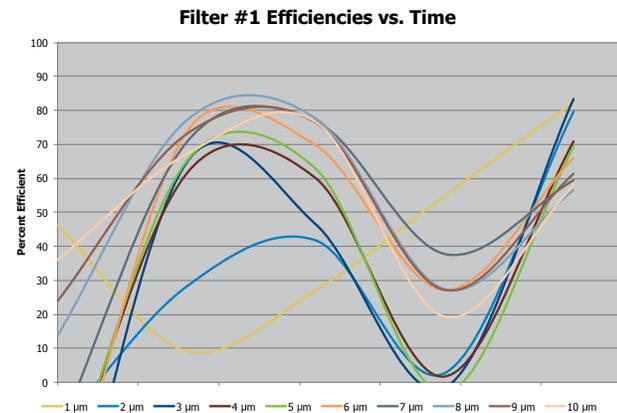
Exhibit 7 depicts filtration efficiency at each µm size over the duration of test #1. The filter starts at a very low efficiency, then increases quickly to about 75%, only to drop off significantly and then reach an efficiency again of about 65% before the test run ended at about 37 hours due to excessive leakage back to tank.

It is important to note that in Exhibit 7 the general efficiency begins to crash around 30 hours for all µm sizes.

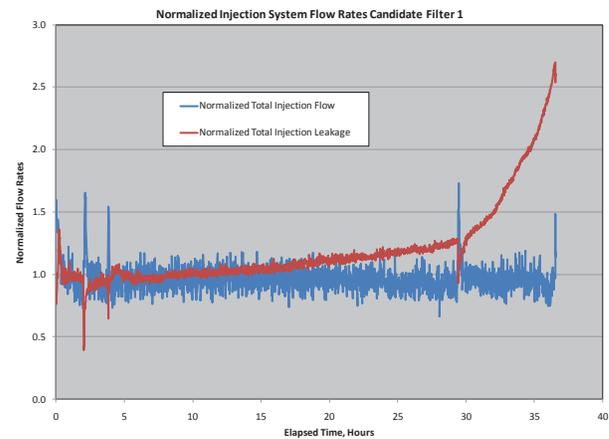
Exhibit 8 below shows the injector flow rate data. Around 30 hours, the normalized total injection leakage flowing back to tank increases dramatically. As noted before, this tends to correlate directly to particulate damage, first indentations and then erosion of the injector seat surfaces.

In this case, the injector failed at 37 hours and testing was terminated. The average 2 digit $\geq 4 \mu\text{m}/\geq 6 \mu\text{m}$ ISO code determined by optical patch counting method for this test was ISO 20/20 to 19/19. This is perhaps a 1-2 ISO code drop from the pre-filter concentration, indicating the filter was not removing nearly enough material to protect the injectors.

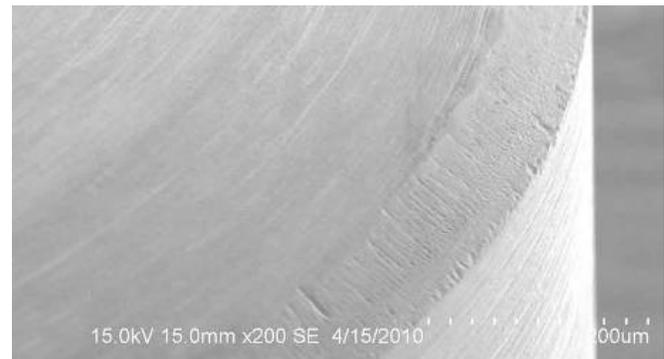
The SEM images of the injectors show severe damage from hard particulate.

SEM: Test #1 lowest leakage lower valve seat at 200X magnification.

Note the severe erosive channels on the sealing surfaces from hard particulate in the fuel at high pressures cutting the surface. These erosion channels are created after minor indentations initially form and begin to connect together, establishing a leak path that erodes severely if particulate continue to pass through the system.

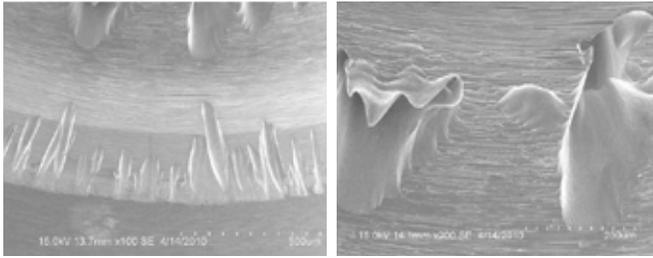
SEM: Test #1 highest leakage lower valve seat at 100X on left and 200X on right.

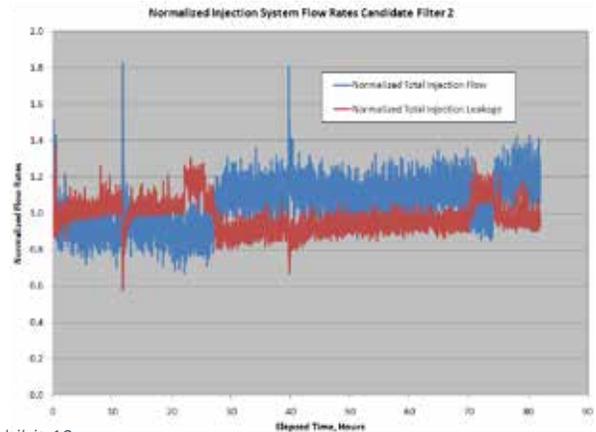
Exhibit 10

Overall, the filter had an efficiency in the 70% range throughout the 80 hour test. The test was run to completion, because the injector leakage back to tank did not increase to a point that the fuel system would fail. In the injector data Exhibit 10, there appears to be at least a slight correlation with the efficiency data in Exhibit 9 in that the normalized injector leakage back to tank changes when the efficiency does. However, there is no telltale spike in leakage at catastrophic failure, only evidence of hard particle impacts on the seat surfaces, which indicates that damage has occurred but erosion has not yet developed extensively.

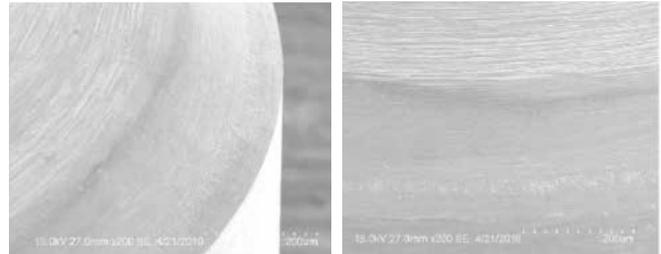
SEM: Test #2 highest leakage upper valve seat at 200X magnification.

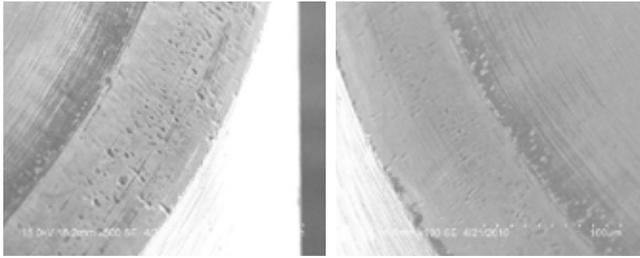
The highest leakage lower valve seat had one extreme channel of erosion (not pictured) and pitting at the seal faces. This is similar to the initial damage seen in the shorter duration narrow cuts of dust testing done as

SEM: Filter test #2 highest leakage lower valve seat at 500X magnification.

preliminary work in the project. A continuation of this level of contamination would likely lead to numerous erosion channels across the seal surfaces and catastrophic failure. It is not known if this damage occurred as a one-time incident around the 30 hour mark or was ongoing due to the average efficiency over the 80 hour test.

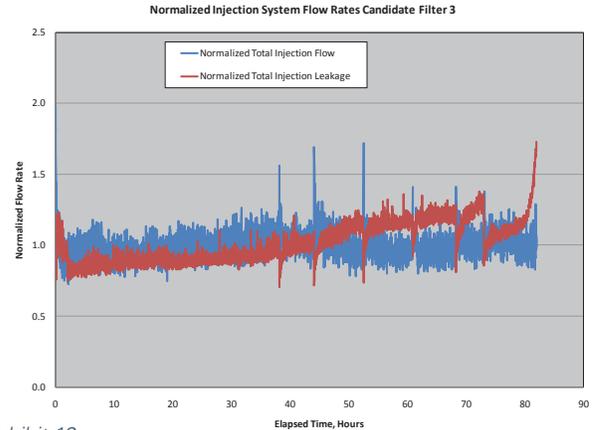
Exhibit 12 shows data on injector flow to cylinder and leakage back to tank. The injector leakage was increasing over the course of the test, but did not spike dramatically towards failure until very late in the 80 hour test.

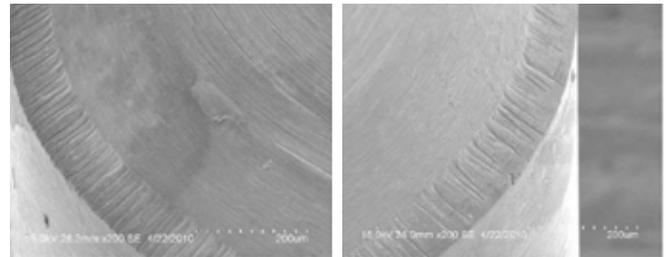
Test #3 injectors were disassembled and inspected for damage using SEM imaging. Damage to injectors included significant erosion across the upper valve extending the width of the seat and extensive erosion on the lower valve seat and into the valve stem.

SEM: Highest leakage upper valve seat 200X magnification.

As shown above, significant damage has been done to the seats in the injectors, and their ability to function properly is compromised.

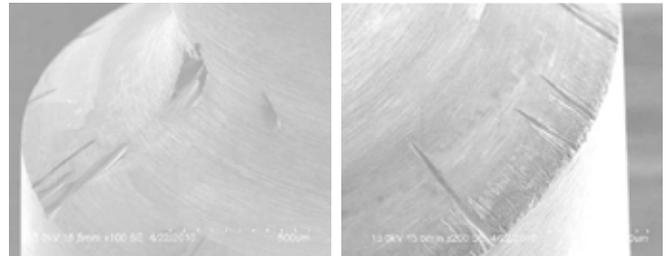
SEM: Highest Leakage lower valve seat 100X magnification on left and 200X magnification on right.

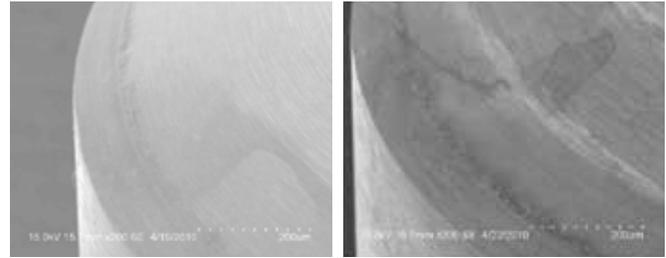
The lack of change in leakage should correlate to minimal injector seat damage in the SEM analysis. In the SEM images below there is little more than breaking wear on seal surfaces.

SEM: Lowest (left) and highest (right) leakage lower valve seats at 200X magnification.

As seen in the images above, there are only a few hard particle impacts at the seal interface and no evidence of any erosive wear in the system. This example shows no degradation similar to the first three filtration tests with indentations due to seal faces closing, particles being present and then erosion across the seal faces as the indentations connect and allow leakage.

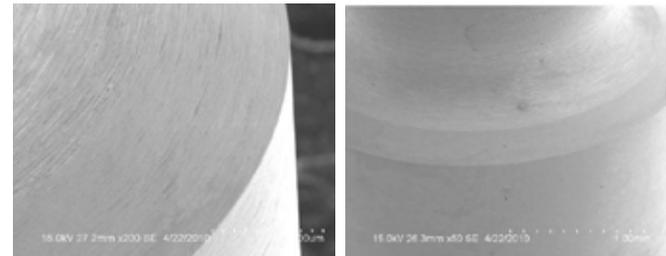
SEM: Highest leakage upper valve seat images at 200X magnification left and 50X magnification right.

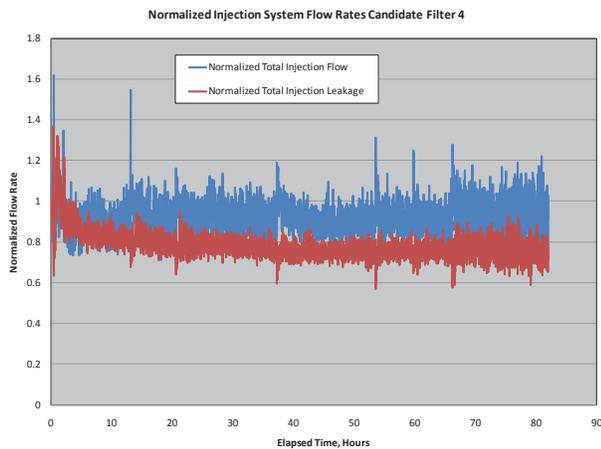
Exhibit 16 shows the data on injector flow to cylinder and leakage back to tank. As shown, the injector leakage did not change significantly over time in the 80 hour test.

It is theorized that the initial debris load identified in the efficiency data correlates to the early initial change in leakage. The system ran consistently for the remainder of the test. A mechanical integrity filter issue or lack of actual filtration efficiency are unlikely causes for this result considering the high efficiency performance during the

remainder of the test. It seems most likely that as the test started, a source of debris was entrained in the fuel beyond the filter. Because any damage did not seem to progress over time, and because the filter continued to remove most of the introduced dust, it appears the filter was functioning properly over the course of the test.

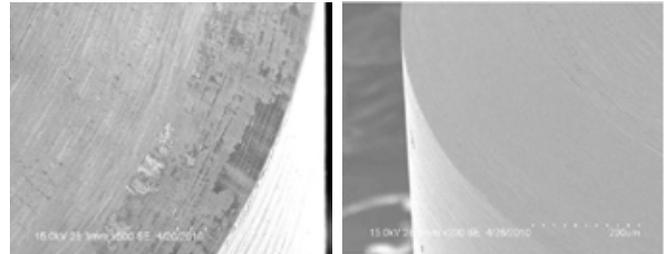
The SEM images below show very little damage other than a possible large impact from a very large, hard particle.

SEM: Lowest leakage Upper Valve Seat 500X magnification left and highest right at 200X magnification.

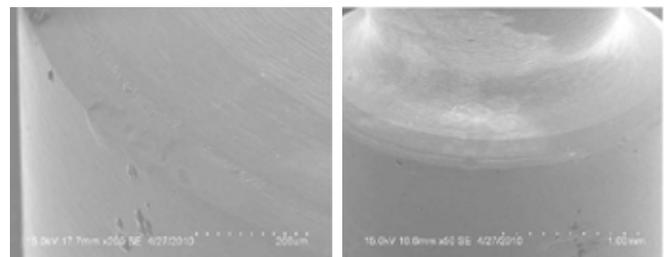
SEM: Highest Leakage lower valve seat 200X magnification left and 50X magnification right showing the large indentation on the edge.

Note that the large indentation on the edge of the surface looks nothing like other damage on the test injectors in the rest of this report. This example also shows no degradation similar to the first 3 filtration tests with indentations due to seal faces closing with particles being present followed by erosion across the seal faces as indentations connect and allow leakage.

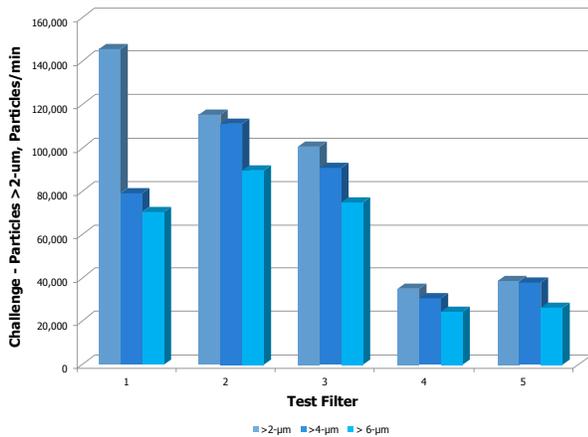
Exhibit 17

In Exhibit 17, the graph depicts the average number of particles per minute counted after the filter. This correlates to the average ISO cleanliness of fuel downstream of the filter over the course of the test. The ISO codes were noted above in each case.

There is a notable difference between filters 1-3 and filters 4-5. Filters 1-3 have relatively high average counts compared to filters 4 and 5 with much lower counts. This difference correlates strongly with the damage seen in the HPCR injectors analyzed for each filtration test and the wear particle tests established without filtration.
