The Effect of Hard Particle Wear on Diesel Injectors

Summary of Industry Cooperative Diesel Injector Hard Particle Wear Testing Conducted at Southwest Research Institute (SwRI)

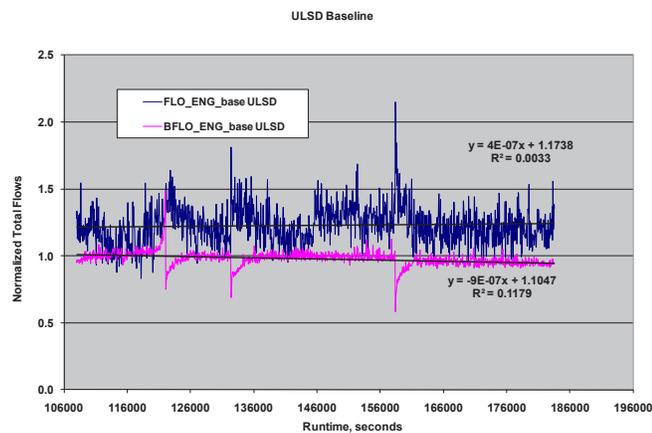
Exhibit 3 shows fuel injector flow rates to the engine (FLO_ENG) and flow back to the fuel tank (BFLO_ENG) over time during the break in base line test on ULSD.

Note that the flow rates are staying essentially stable and parallel over time. This is the expected behavior for injector flow performance on fuel that does not contain sufficient hard particulate to cause damage. The 3 corresponding peaks over the course of this test are start-up condition related. The test bench was not run continuously, but stopped overnight and testing resumed again the next day. Once the base line performance and behavior were established on pristine clean fuel, the introduction of known cuts and concentrations of test dust into the fuel system could be done to assess damage.

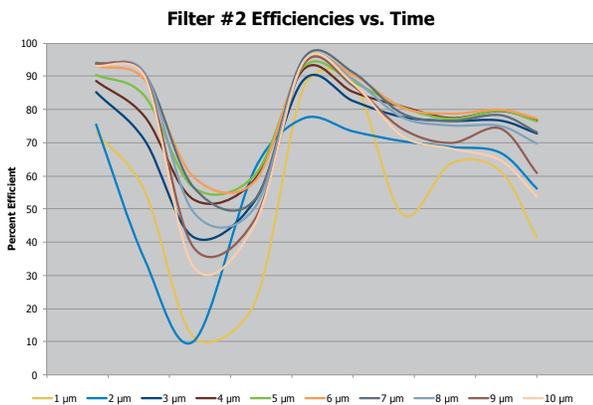
In Exhibit 9, the graph depicting filtration efficiency at each μm size over the duration of test #2. The filter starts at approximately 80% efficiency, decreases quickly to 20-40%, only to recover and then slowly drop off until the end of the test run at 80 hours. The filter produced 2 digit $\geq 4 \mu\text{m}/\geq 6 \mu\text{m}$ ISO cleanliness downstream of the filter ranging from ISO 18/17 to 20/18.

Overall, the filter had an efficiency in the 70% range throughout the 80 hour test. The test was run to completion, because the injector leakage back to tank did not increase to a point that the fuel system would fail. In the injector data Exhibit 10, there appears to be at least a slight correlation with the efficiency data in Exhibit 9 in that the normalized injector leakage back to tank changes when the efficiency does. However, there is no telltale spike in leakage at catastrophic failure, only evidence of hard particle impacts on the seat surfaces, which indicates that damage has occurred but erosion has not yet developed extensively.

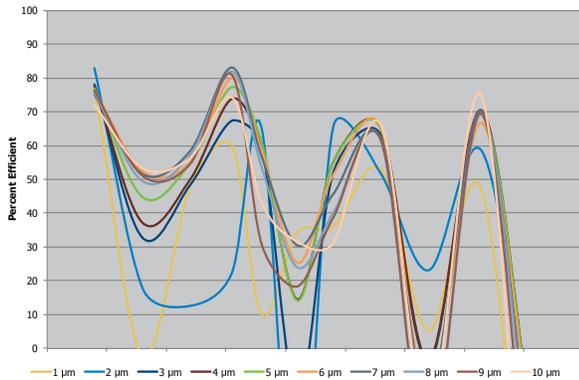
Exhibit 11 depicts filtration efficiency at each μm size over the duration of test #3. This filter starts at approximately 80% efficiency, then decreases quickly to about 45% only to recover and sharply drop off repeatedly and more severely over the course of the test. The test ran the full 80 hours. The filter produced 2 digit $\geq 4 \mu\text{m}/\geq 6 \mu\text{m}$ ISO cleanliness codes downstream of the filter ranging from ISO 12/12 to 15/15. The filter had excursions of efficiency at times that appear to allow more particles downstream than are entering into the filter, thereby creating negative efficiency on some particle sizes for some periods during the test.

The decreases in efficiency seem worsen over time as the test progressed. The overall efficiency of the filter over the course of the test was in the 50% range.

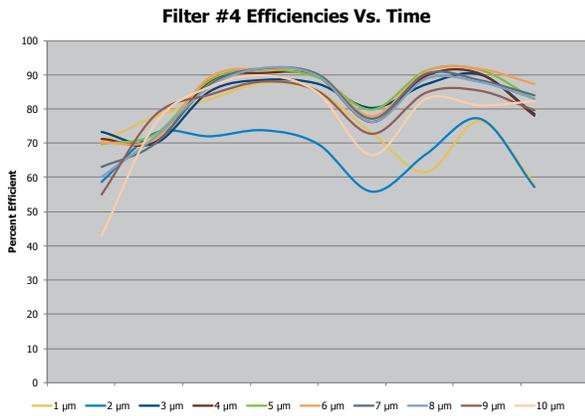
Exhibit 13 depicts filtration efficiency at each μm size over the duration of test #4. This filter runs at approximately 85% efficiency over the course of the test. The test run lasted the full 80 hours. The filter produced 2 digit $\geq 4 \mu\text{m}/\geq 6 \mu\text{m}$ ISO cleanliness codes downstream of the filter ranging from ISO 12/12 to 11/11. The filter had only a modest excursion of efficiency at about 50 hours, but recovered.

As seen in Exhibit 13, the filter system performed well and consistently compared to the previous examples with no large excursions to low efficiency. This should correlate to good protection of the fuel injection system preventing an increase in leakage back to tank.

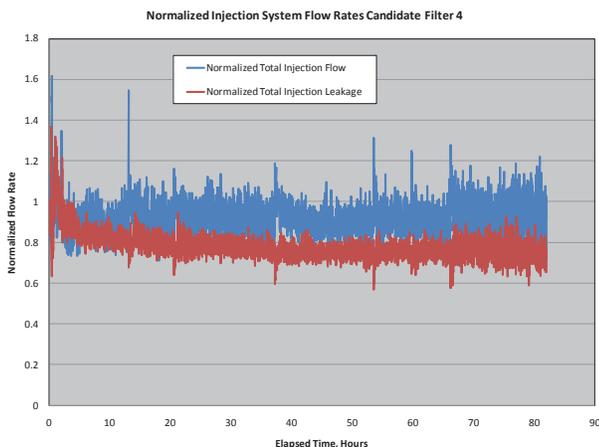
Exhibit 14 shows data on injector flow to cylinder and leakage back to tank. As shown, the injector leakage did not change significantly over time in the 80 hour test.

The lack of change in leakage should correlate to minimal injector seat damage in the SEM analysis. In the SEM images below there is little more than breaking wear on seal surfaces.

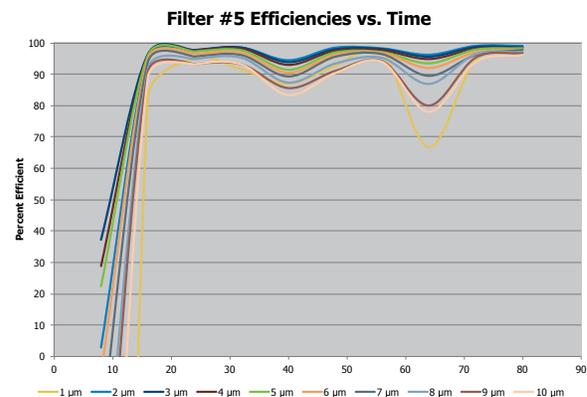
The graph in Exhibit 15 depicts filtration efficiency at each μm size over the duration of test #5. This filter runs at approximately 95% efficiency over the course of the test.

The test run lasted the full 80 hours. The filter produced 2 digit $\geq 4 \mu\text{m}/\geq 6 \mu\text{m}$ ISO cleanliness codes downstream of the filter ranging from ISO 10/10 to 13/12. The filter had only a modest excursion of efficiency at about 65 hours but recovered. The initial efficiency measurement appears very low, but the filter quickly increased to approximately 95% efficiency for the duration, suggesting there may have been some contamination in the bench at test start.
