# Clean Fuel & Lubricant Solutions

## ROCK ON: FILTRATION INCREASES CRUSHER GEARBOX LIFE BY 3.5x

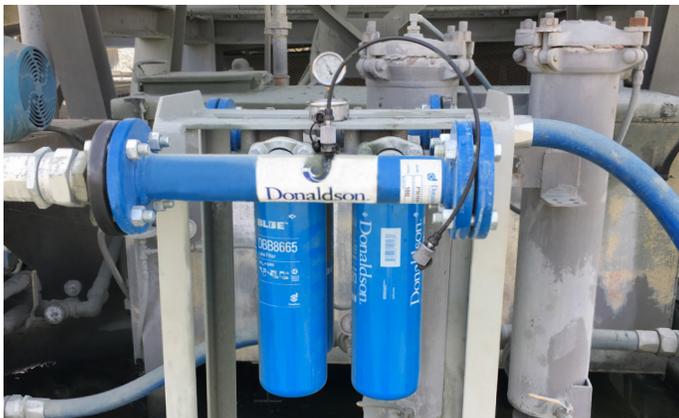
*Donaldson solution shown in the front with a Mini Mess Sample Port attached to allow proper ISO code readings. The original filters in the back are disconnected, and fluid flows through the Donaldson filters.*

The Donaldson Clean Solutions team recommended installing a manifold at the outlet of the gearbox oil tank with four Donaldson DBB8665 filters with a 7-micron efficiency rating at Beta 2000 (99.95% filtration efficiency on 7 micron and larger particles).

The company's Equipment Manager decided to put the recommendation to the test and installed the filter manifold on one of the cone crushers.

These filters cleaned the oil before it reached the crusher's gearbox and other sensitive components.

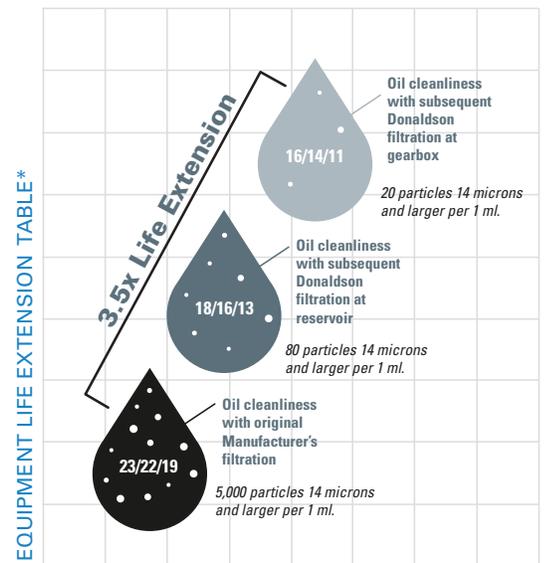
## CLEANLINESS ON THE RISE

### ISO CLEANLINESS CODE

\*By reducing the ISO cleanliness codes of the crusher oil by 8 ISO codes, the average expected life extension of the gearbox and components is 3.5x - Based on Noria Corporation's Life Extension Table.

An on-site fluid analysis of the crusher's gearbox oil revealed a distressing ISO cleanliness level of 23/22/19, more than 125x dirtier than the target ISO cleanliness level of 16/14/11.

However, fluid analysis after the first set of filters was replaced showed a new ISO cleanliness level in the reservoir of 18/16/13, meaning the filters were doing exactly what they were supposed to do: clean the oil, meet target cleanliness levels, and protect critical equipment.

**The Donaldson filtration system reduced the amount of contaminant reaching the gearbox by 8 ISO codes. The oil was 125x cleaner, thereby extending the life of the gearbox by 3.5x.\***
